## Professional Opinion

## Restoration Viability

55 - 57 Nelson Place (Oriental Hotel)  
Williamstown Victoria

*Date:* 10 February 2014

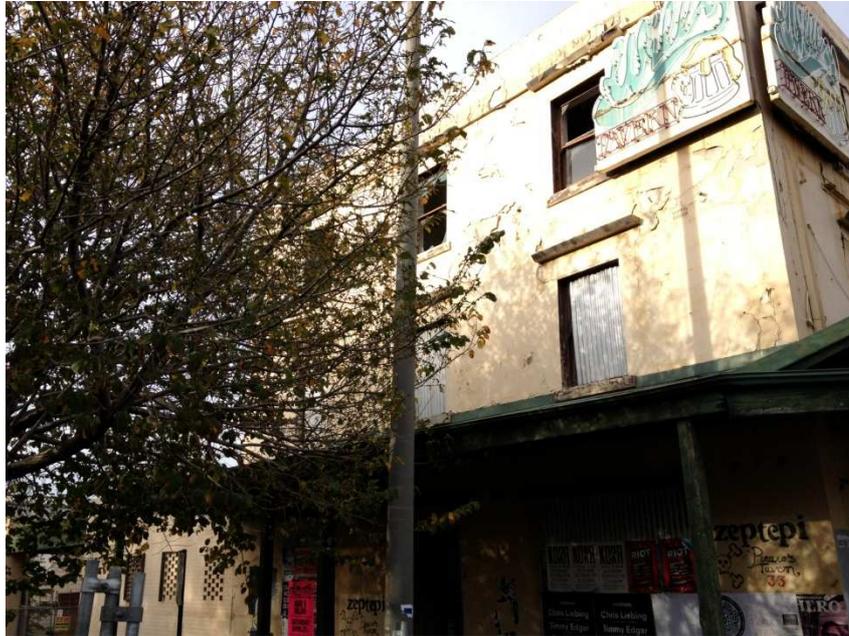
Figure 2 - Northern Façade (22 May 2013)

The northern façade similar to the other façades experienced a high amount of cracking to the first and second storey with less prominent cracking to the ground floor. Whilst it appeared there was less cracking to the ground floor it could not be fully assessed due to the presence of numerous posters to the ground floor that may hide possible cracks. There was one significant vertical crack noted to the ground floor near the north/eastern corner.

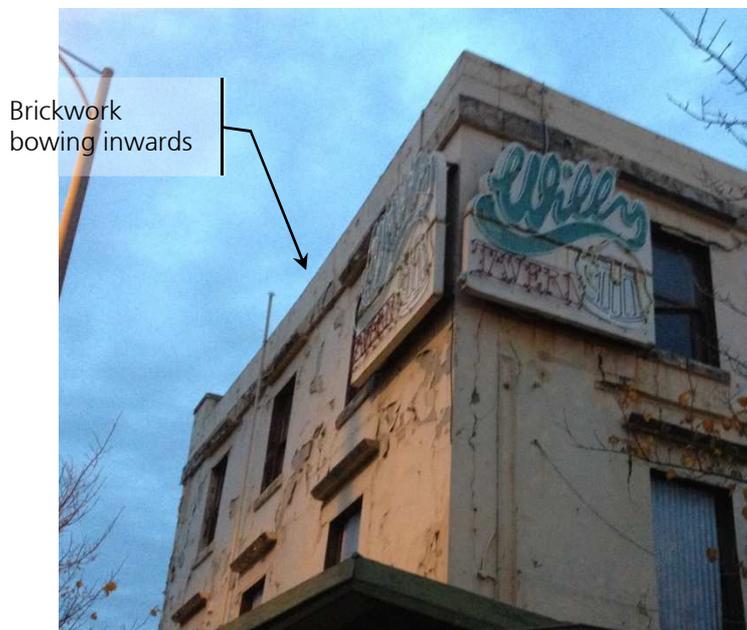
Figure 3 - Eccentricity of wall at the top of the Northern façade (12 June 2013)

The top of the façade bows visibly inwards as illustrated in figure 3. The actual amount of eccentricity could not be accurately surveyed due to the limited access as previously discussed.

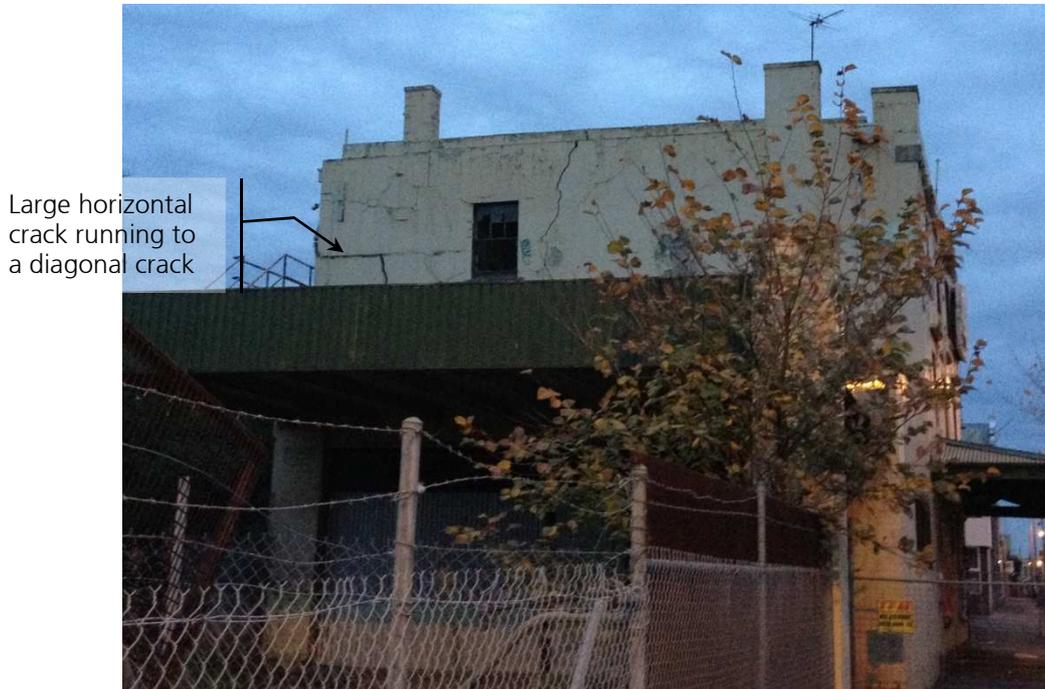
Figure 4 - Eastern facade (12 June 13)

The eastern façade could only be viewed from the street due to the restricted site access. There were two significant cracks that were visible, one large horizontal that extends to a diagonal crack near the corner of the building (refer figure 4). The other significant crack was a mainly vertical crack at the centre of the façade that appears to extend from the roof to the second floor. The rain head that transports the rain

Large horizontal crack running to a diagonal crack

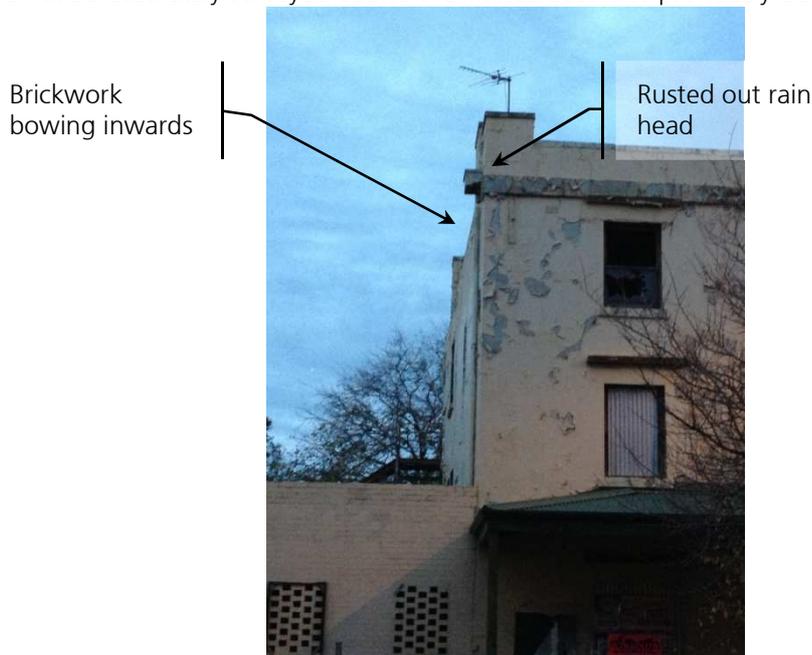
Figure 5 - Eccentricity of eastern façade (12 June 13)

water from the roof to the downpipe has completely rusted out which means that excess water will possibly get into the brickwork further degrading its integrity (refer figure 5).

Brickwork bowing inwards

Rusted out rain head

It is recommended should the building be retained that the downpipes should be remedied immediately to stop further degradation of the existing structure and to also stop water shedding to the footings.

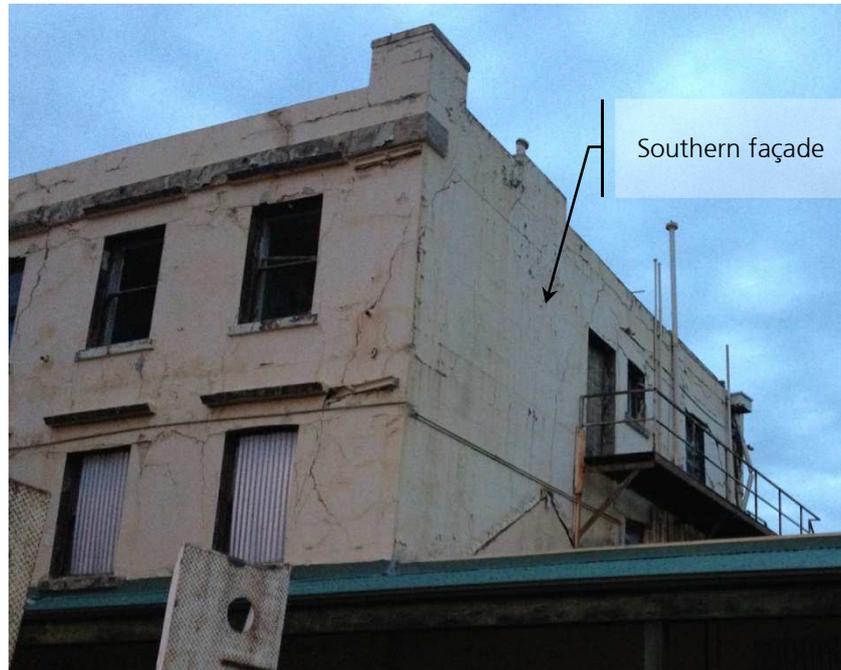
Figure 6 - Southern façade (12 June 13)

The southern façade's cracking is seen as minor at the south/western corner and appears to develop along its length until major cracking to south/east corner is experienced. There is a steel walk way to an access door, the steel walk way appears to be in moderately poor condition.

The steel walk way to the southern façade appears to be struttred from the brickwork. This is unlikely to be acceptable engineering wise and is almost certainly structurally unacceptable given the current brickwork condition.

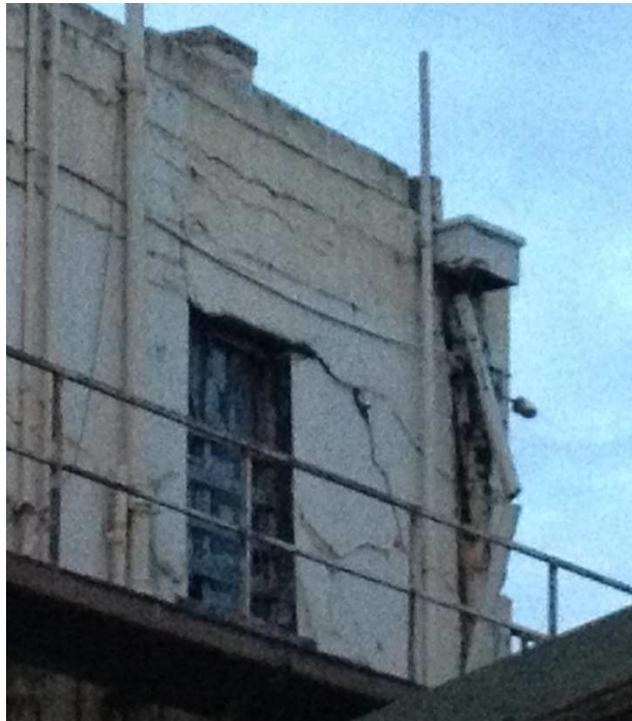
Figure 7 - Major cracking of brickwork to south/eastern corner

The cracking that can be seen on the south/eastern corner (as seen in figure 7) is severe extreme and it is assumed that there would be no structural continuity between south and east walls due to the size of the crack.

The drainage to the down pipe in the south/eastern corner is completely non-existent due to the rusting out of the downpipe (refer Figure 7). The rusting out of this down pipe would shed water to the façade further damaging brickwork and footings.

The cracking to the south eastern corner is of concern as it is important to the structural integrity of the building that the corners are structurally engaged. At present due to the condition of the brickwork at this corner no structural engagement could be considered which is a concern.

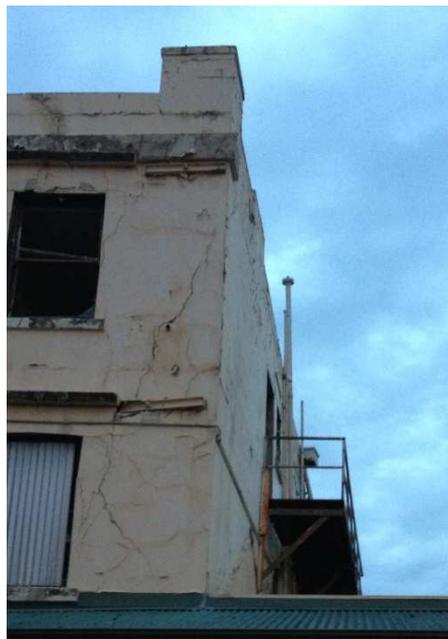
Figure 8 - Eccentricity of eastern façade (12 June 13)

Similar to other walls mentioned the southern façade bows inwards (refer figure 8), the amount of bowing to this face is slightly less than on the north face and east face however it is still seen as significant.

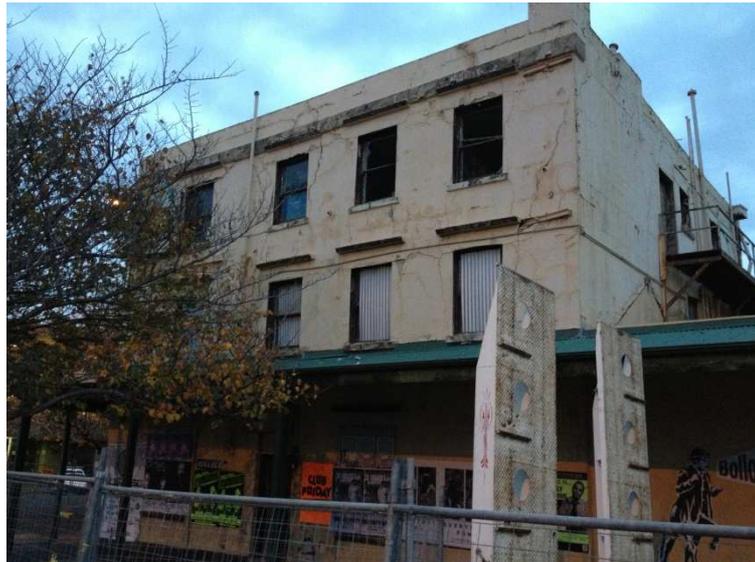
Figure 9 - Western facade (12 June 2013)

The western façade experiences major tension cracks at its centre and also at its corners. There are larger cracks also seen on the ground floor at the north/western corner. The bowing of this wall is in the opposite direction to the north, south and east walls and leans outwards towards the street.

As the wall bows outwards it is of greater concern, as the likely direction of collapse should it occur is onto the street. This is the only wall that bows outwards and it is recommended that it is propped immediately for the safety of the public.

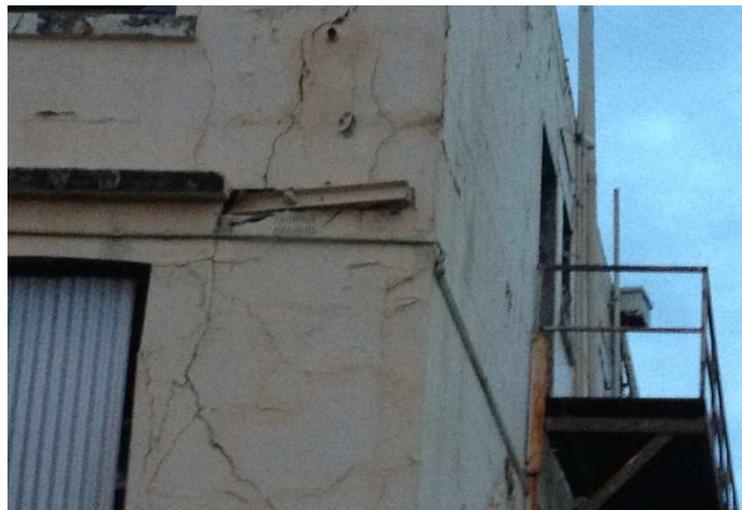
Figure 10 - Brick tie punching into brickwork (12 June 13)

As seen in figure 10 there has been a steel channel installed to the south western corner, this was presumably installed as a tension tie to help tie in the brickwork due to cracking/leaning of brickwork. It appears that since the installation of this tension tie further outward bowing of the wall has occurred and as a result the stiff tension tie has pierced the brick work as it has moved outwards.

The movement seen at the tension restraint on the western façade is of concern (refer figure 8). The concern is twofold: one being that as the tension backer (the steel channel supporting the brickwork) has pierced the brickwork it no longer restrains the brickwork from bowing outwards. The other concern is

that it indicates that the wall has continued to move outwards since the installation of this tension restraint.
