## Professional Opinion

## Restoration Viability

55 - 57 Nelson Place (Oriental Hotel)  
Williamstown Victoria

*Date:* 10 February 2014

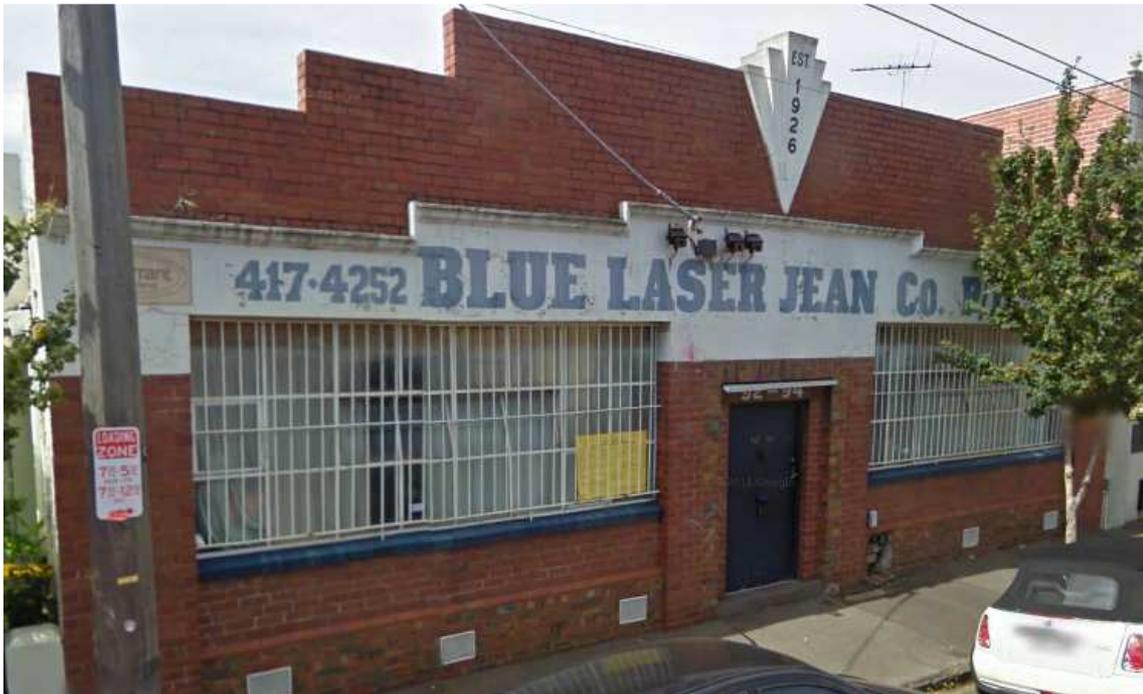
Figure 12 - Existing Building (prior to construction) at 92 Easey st Collingwood

façade as they believed it was a valuable addition to the building and would add character. The façade of the building can be seen below in figure 12. The façade had an approximate 80mm outward lean from top to bottom on it, this had to be taken into account when design the new lateral restraint from the new internal steel structure.

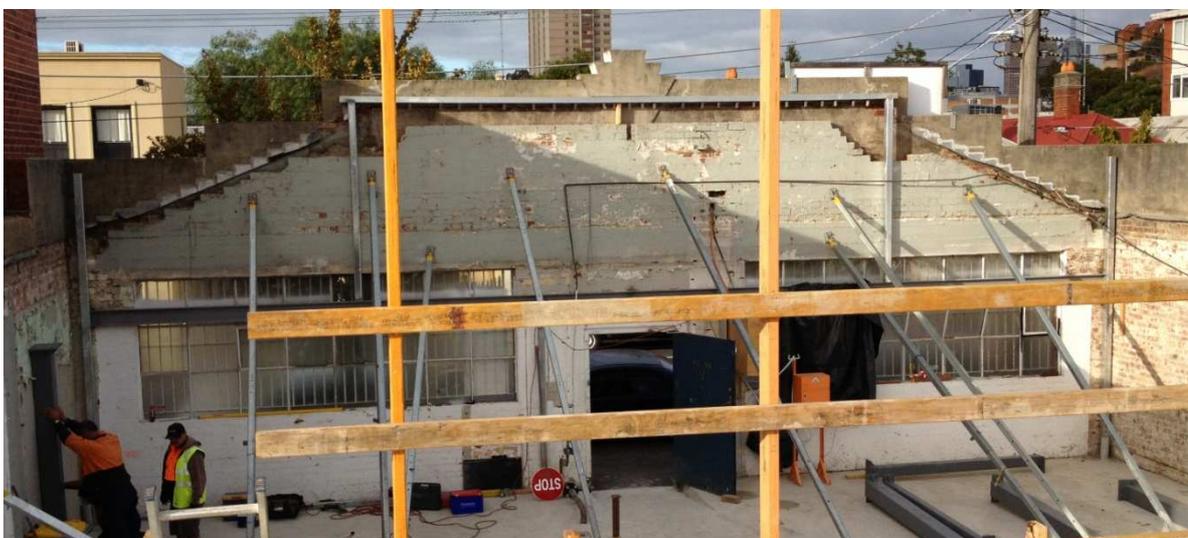
Figure 13 - Internal propping of front facade during construction

As there were issues with blocking the footpath externally, the façade was propped internally whilst the internal structure which was made up of light weight steel and timber was constructed. The propping method did not require a gantry type arrangement as described in section 4.1.1 due to the props being internal. The same principle applies however of keeping the external façade and building new a new permanent steel support system. Figure 13 shows the internal view of the building when the façade is supported by diagonal push pull props only.

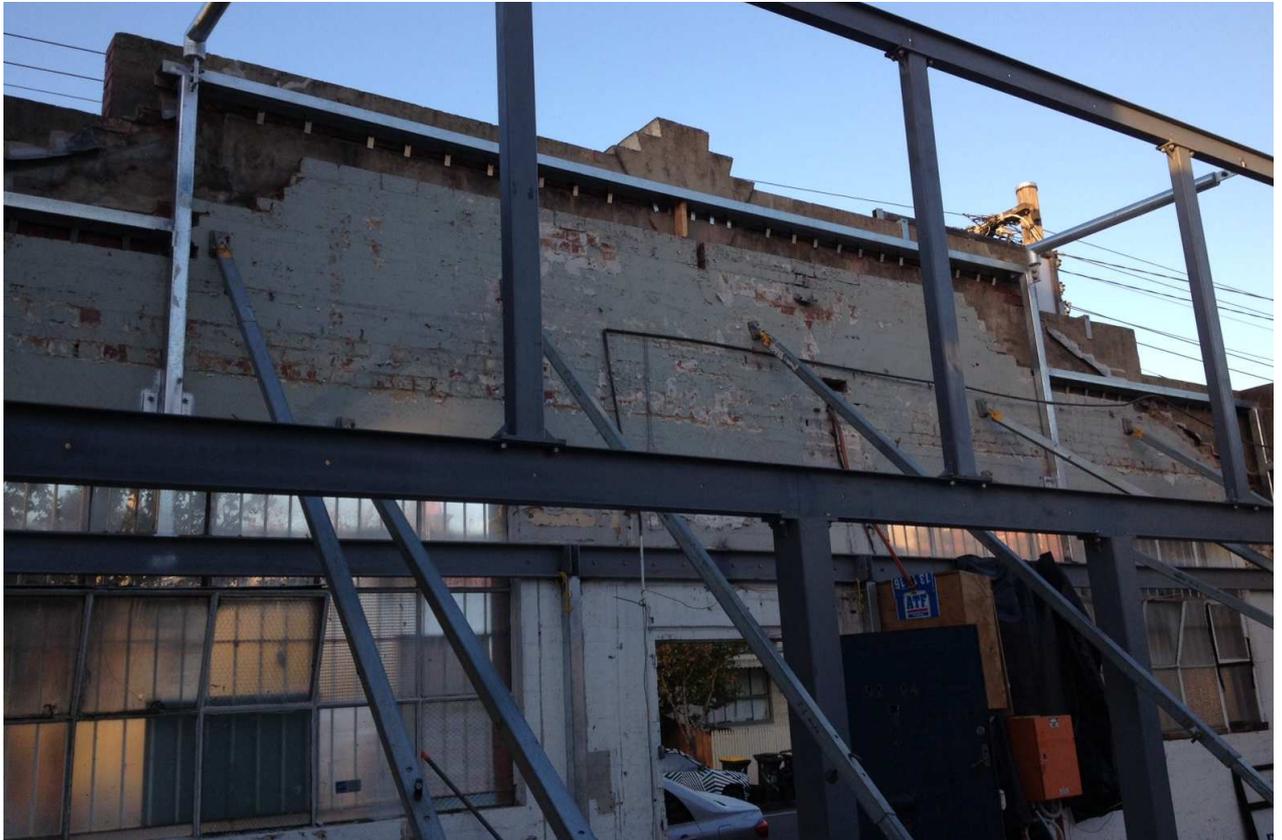
Figure 14 - construction of internal permanent steel structure to support existing brick facade.

Figure 14 shows the new steel frame that has provides the permanent support for the existing façade.

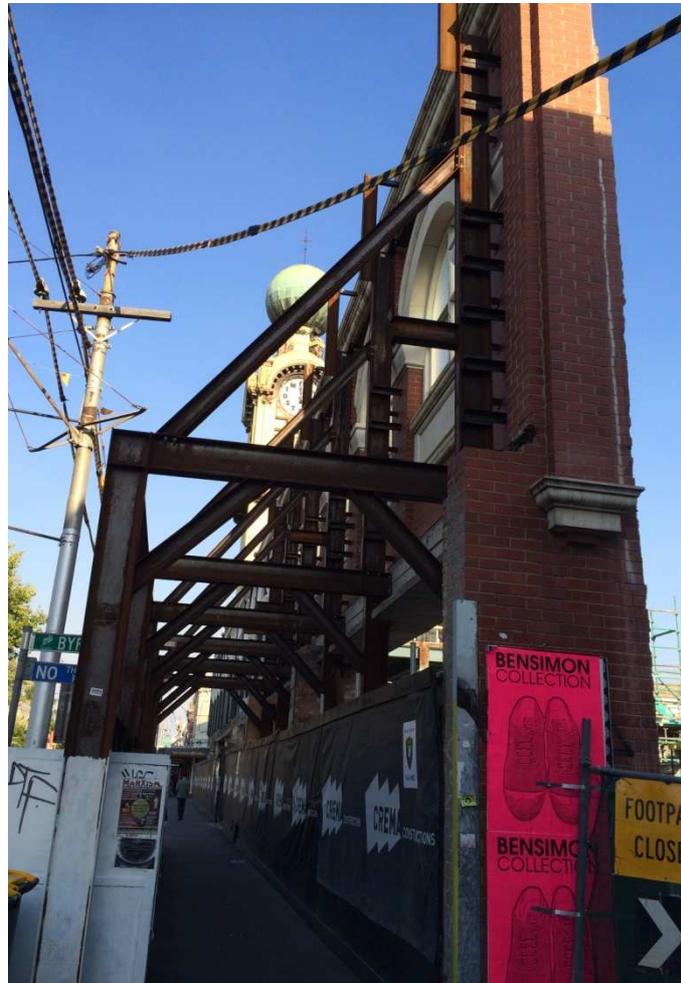
Figure 15 – External gantry façade (with walk way under) support at the old Dimmeys store in Richmond

The landmark Dimmeys site in Richmond which is over a century old is to be re-developed whilst retaining the existing façade. The builders (Crema Construction) used a gantry type system very similar to the type proposed in section 4.1.1 (refer figure 15).

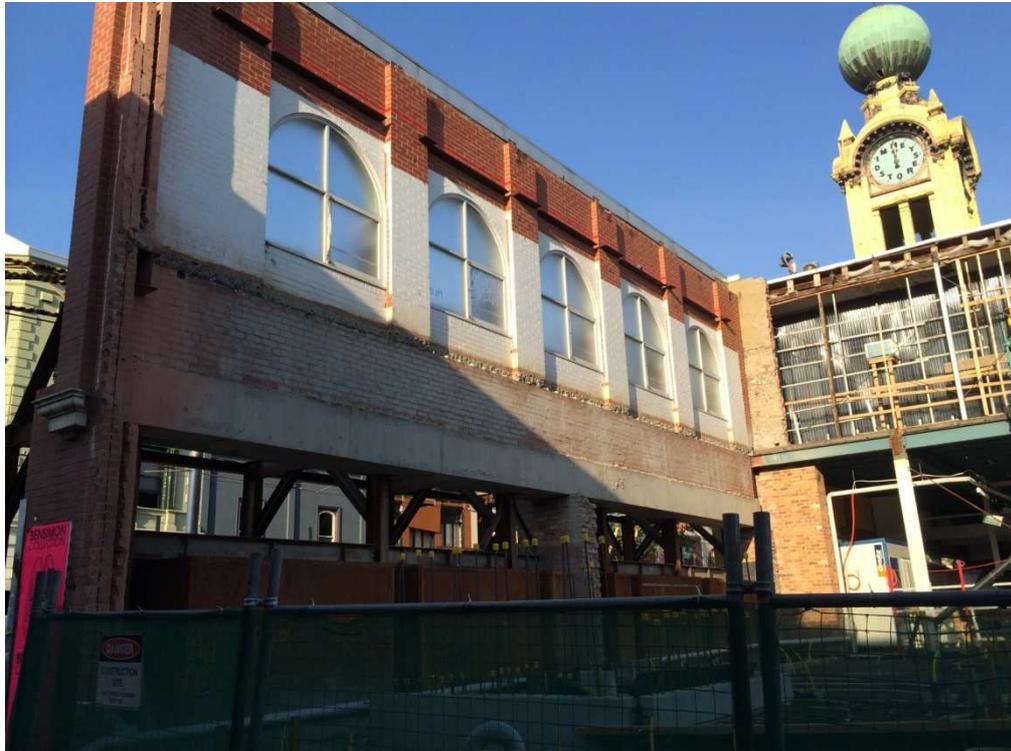
Figure 16 - Internal view of Dimmeys building

Figure 16 shows the internal area of the building that is relatively unencumbered on the inside of the building to allow construction to proceed.

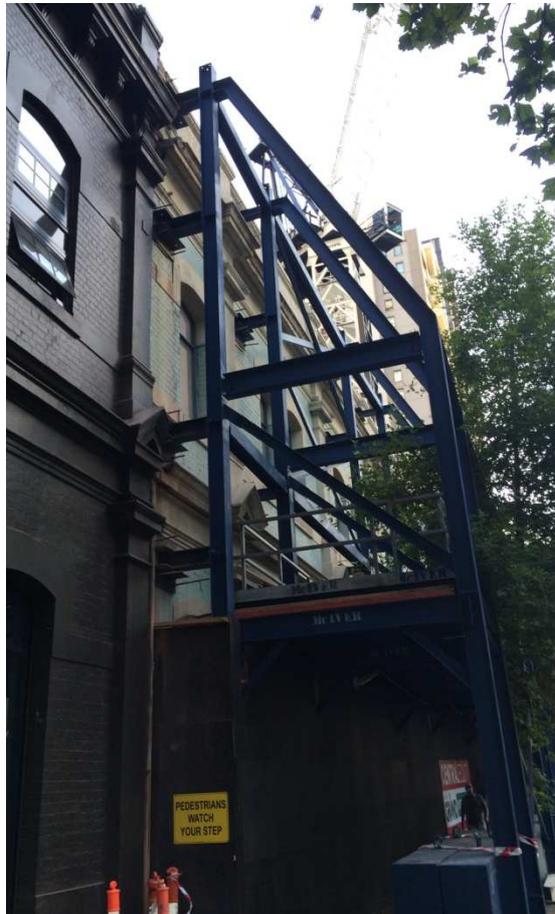
Figure 17 - External Gantry (with walk way under) at 151 City Rd Southbank

Southbank grand is a high rise building where developers have chosen to keep the existing brick façade whilst building a large high rise building on the internal site. Figure 17 shows the external gantry structure that allows pedestrian traffic under, which is again a very similar method of façade retention mentioned in section 4.1.1. Figure 18 is an internal view of the building site which shows a relatively clear building site for the construction.

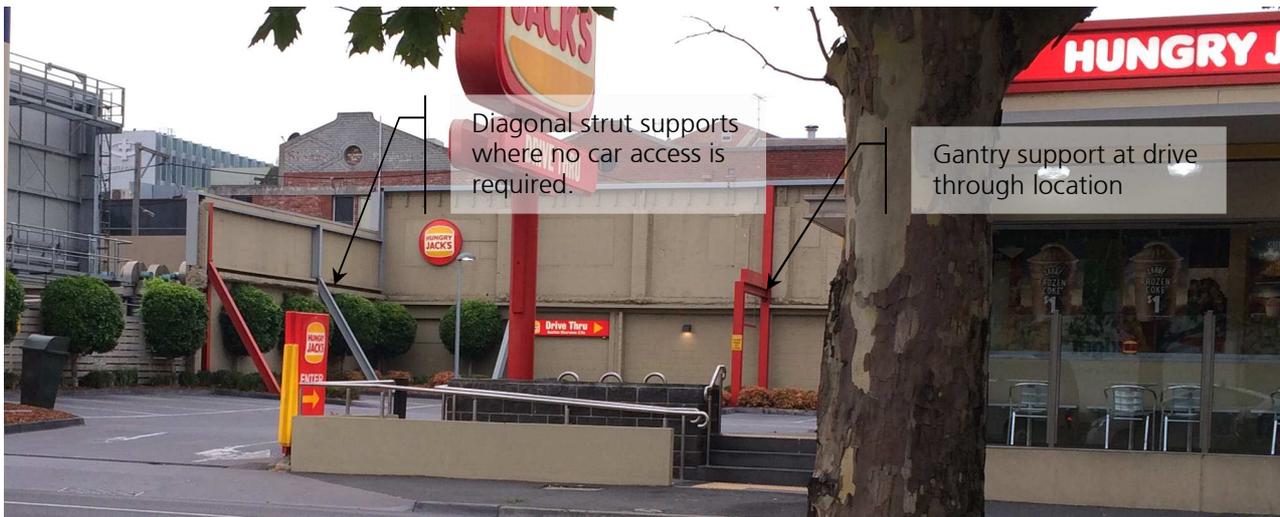
The hungry jacks store on Hoddle St in Richmond has utilised a permanent propping system to permanently retain an existing brick wall, the system uses both angled props and also a gantry prop through the drive through to allow vehicle access, refer figure 19 below
