WITNESS STATEMENT OF CAPTAIN WILLIAM KOREVAAR

FORMER PORT PHILLIP WOOLLEN MILLS ADVISORY COMMITTEE (FPPWMAC)

February 2011

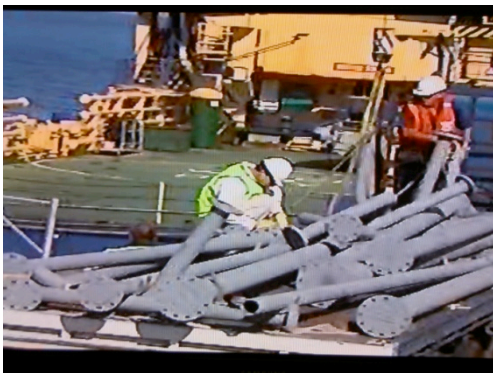
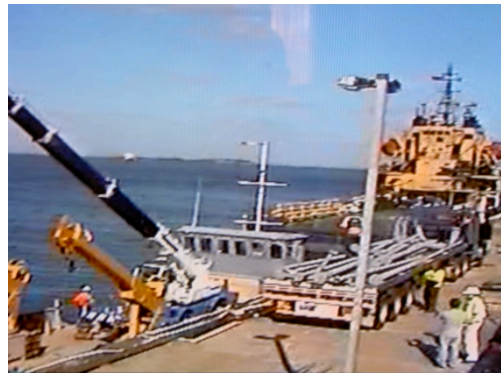
- After the incident it was discovered that large sections of major steel cargo transfer pipeline on Kinna were corroded in excess of 20% beyond minimum thickness permitted by design Classification Society and SOLAS (Safety of Life At Sea Convention) tanker design rules and standards. Such extensive corrosion does not occur over a short period of time and this incident demonstrates not all unsafe ships are able to be detected by Authorities or prevented from entering and operating in Australia by AMSA under Port State Control.
- It was discovered that about 180 metres of corroded cargo pipeline had been covered with “gaffa” tape and painted over to conceal the rust and damage.
- The following images were taken by local witnesses showing some of the replacement pipeline being loaded onto a barge for transport to Kinna whilst at anchor in Westernport Bay.

There were a number of such truck loads of pipe sent to Kinna, such was the scale of corrosion on the ship.

96- **Kinna:** In February 2007, An LPG Tanker, MT “Kinna” suffered an uncontrolled escape of Liquefied Petroleum Gas (LPG), whilst loading at the Esso Long Island Point tanker jetty. The leak was discovered and cargo transfer stopped before fire or explosion occurred and the vessel was removed from the terminal to anchorage in Westernport bay. Uncontrolled escape was then defined as a *Major Incident* by the *Victorian Major Hazard Regulations 2000*.

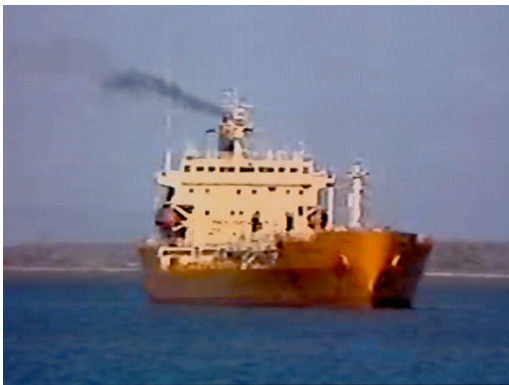
LPG Tanker – Kinna. Hastings 3/2007

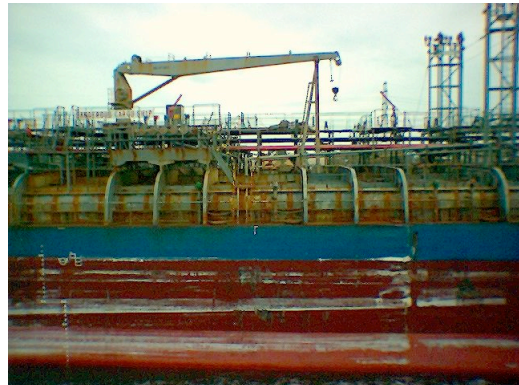
Another “well maintained” tanker, similar to The “Bow Mariner” visiting Coode Island in Maribyrnong, Melbourne, in 2007.

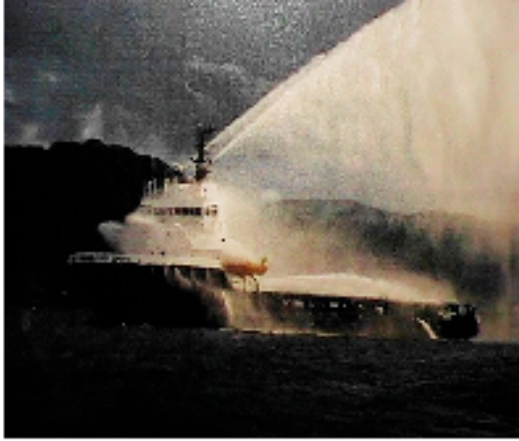
Lady Sandra – Fire Fighting systems

- aa. 1998: I took delivery as Master of a new ship named “Lady Sandra”; a 16,000bhp, 190tonne bollard pull - Fire Fighting Ship - Anchor Handling Tug Supply (AHTS) vessel. At the time, Lady Sandra was one of the largest and most capable Offshore vessels in the world and was the flag-ship of P&O’s international Offshore Industry fleet.
 - i. Providing anchor handling, towage, cargo support and Safety / Emergency Standby services to Oil and Gas Industry offshore rigs in the North Sea, Middle East and South East Asia.
 - ii. **Combat fire** – B-121 Gas Platform / well blow-out in Bombay high Oil Field, on charter to Cud Well Control: (competitor to the Red Adair Company). Photos follow.
 - iii. Emergency assistance and preventative grounding of a sinking offshore support vessel, Malampaya Sound – Philippines

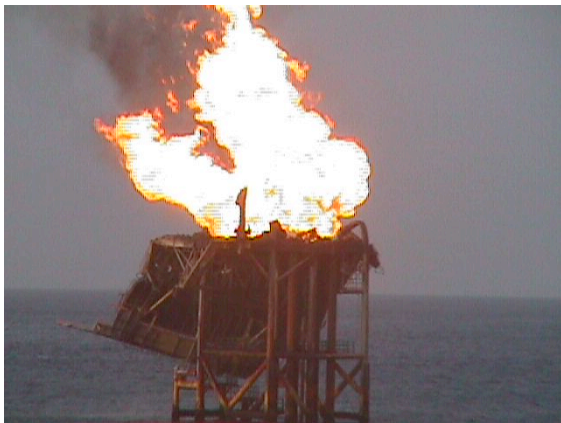
B-121 Gas Platform blow-out: 40 metre diameter fire-ball. Radiant heat felt at combat location 1 km distant.
